COMISIÓN FEDERAL
DE ELECTRICIDAD

Hurricane Odile

La Paz - Los Cabos, BCS

2015 PLS-CADD Advanced Training
and user group meeting

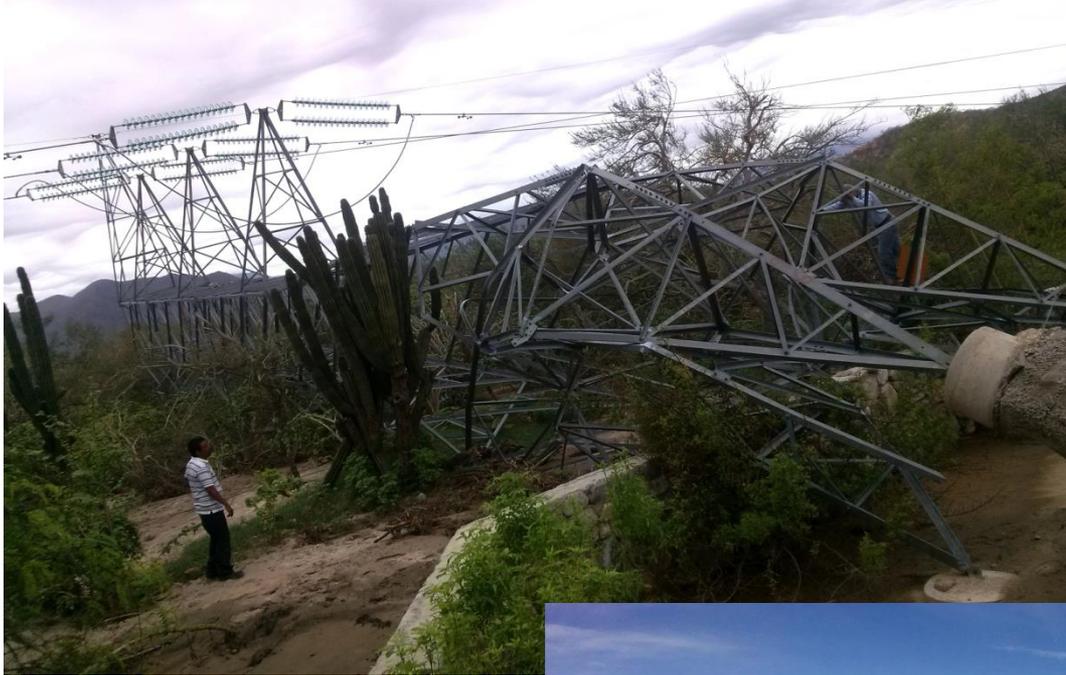
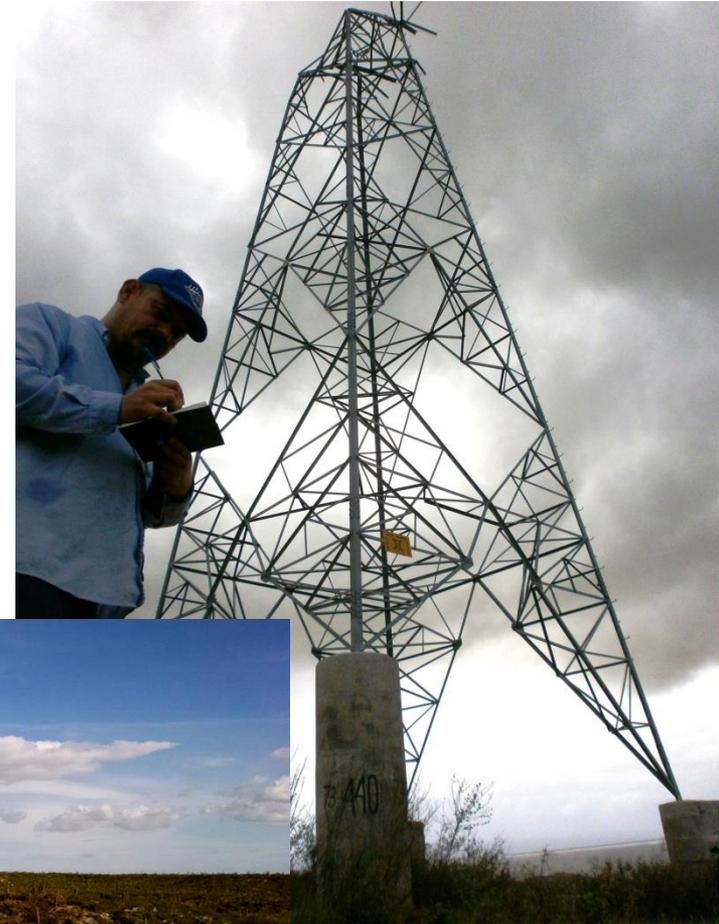
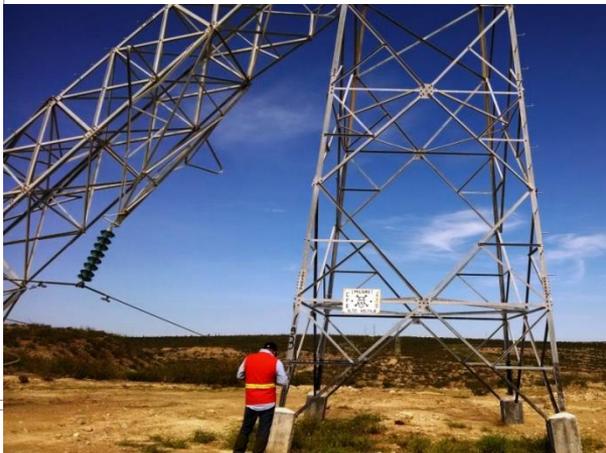
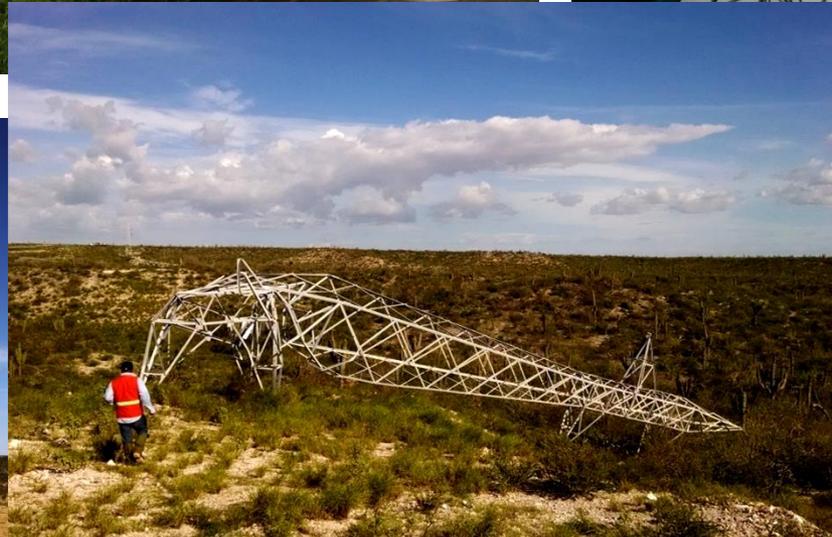
5.- Fotografic Report Damage Verification

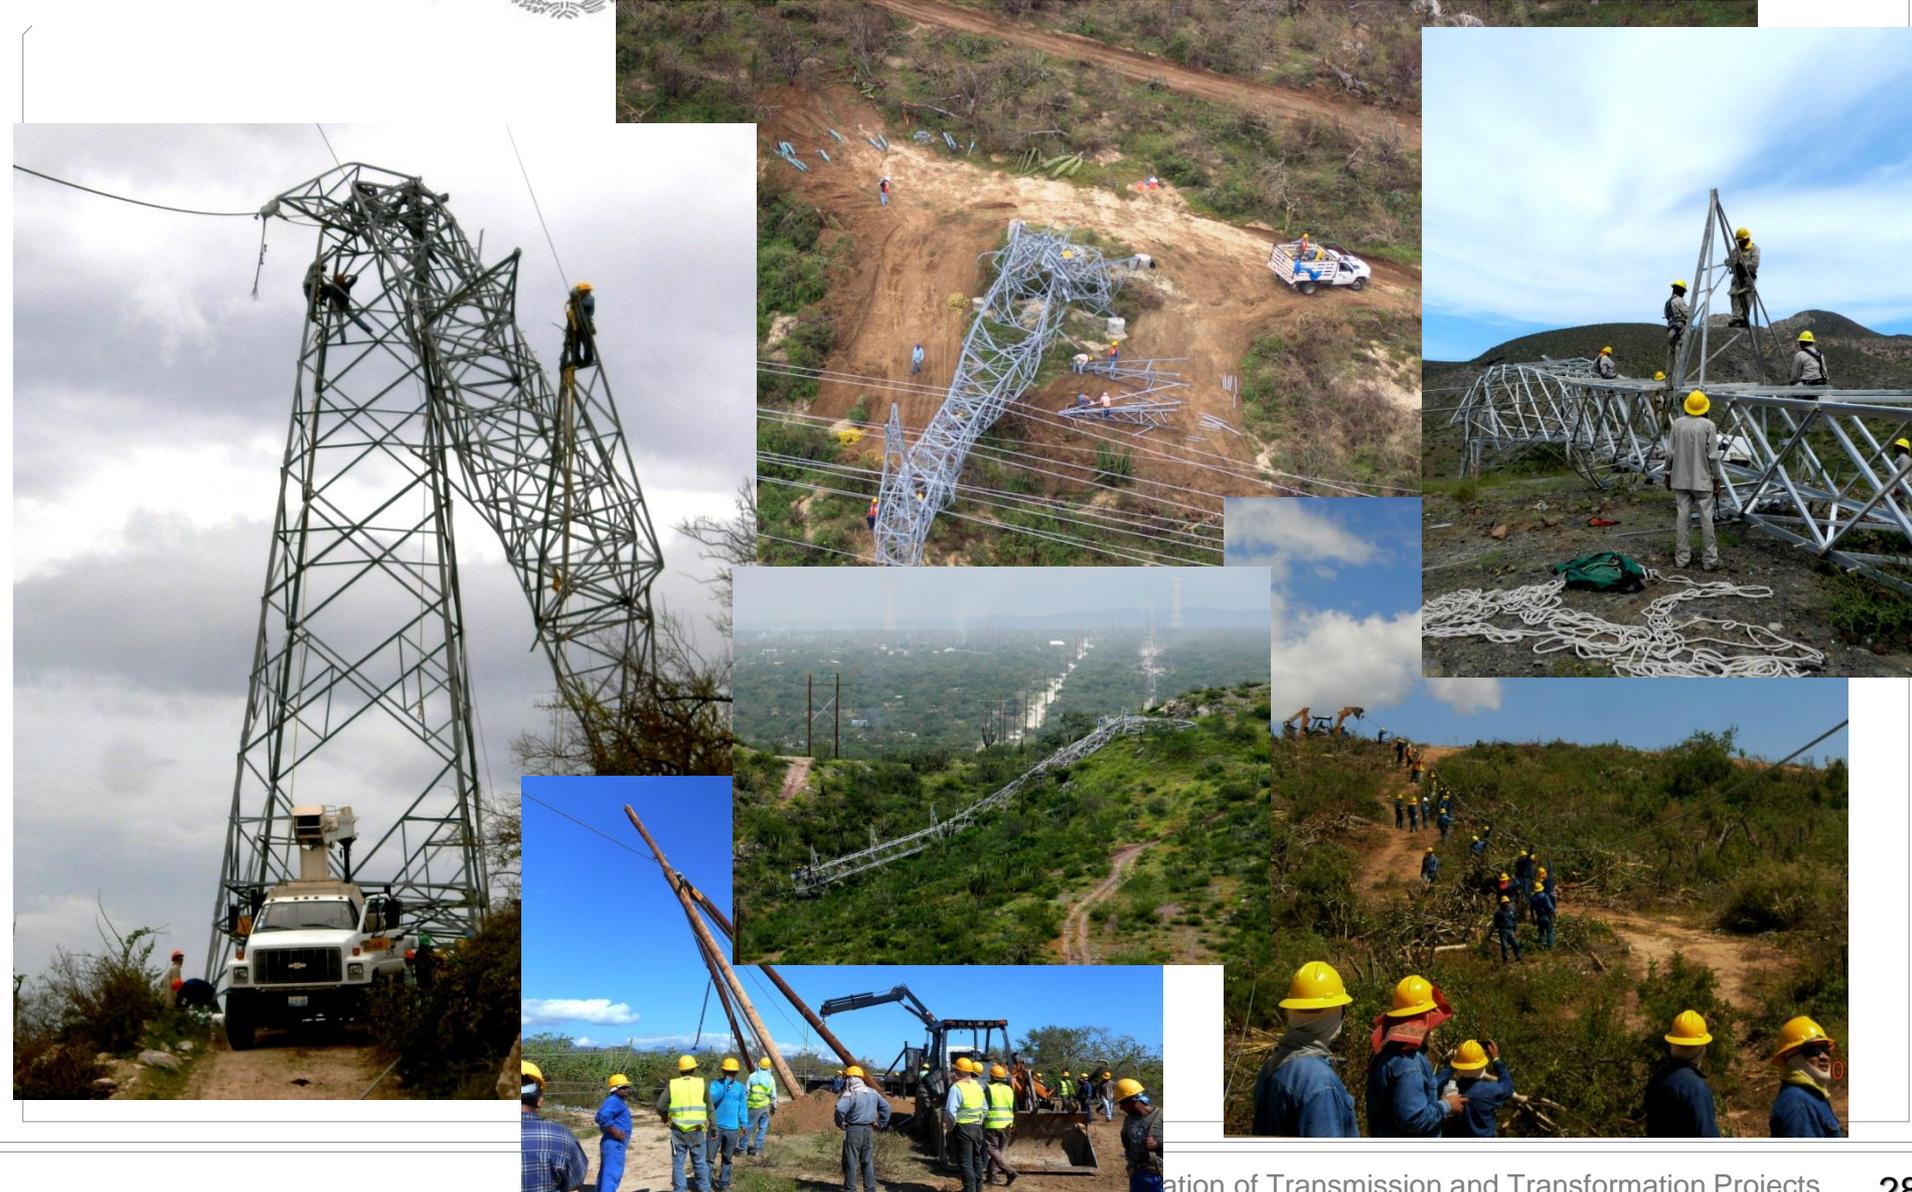
Removing structures

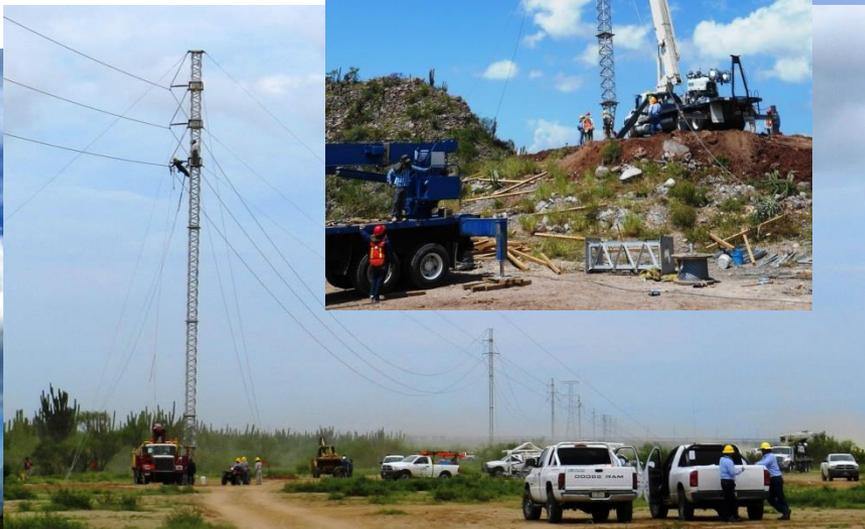
Provisional structures

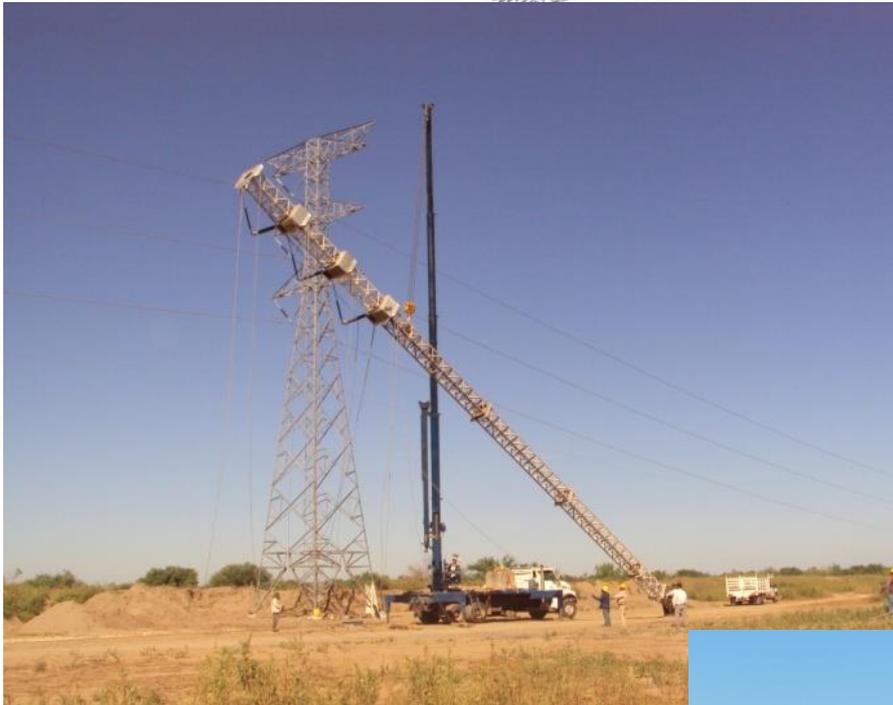
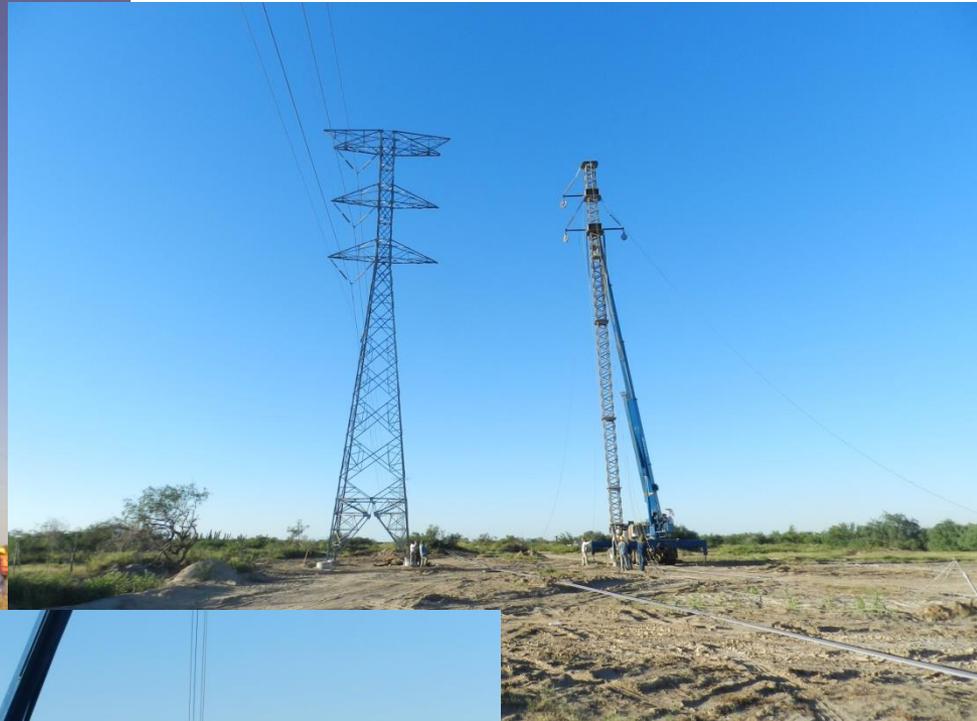
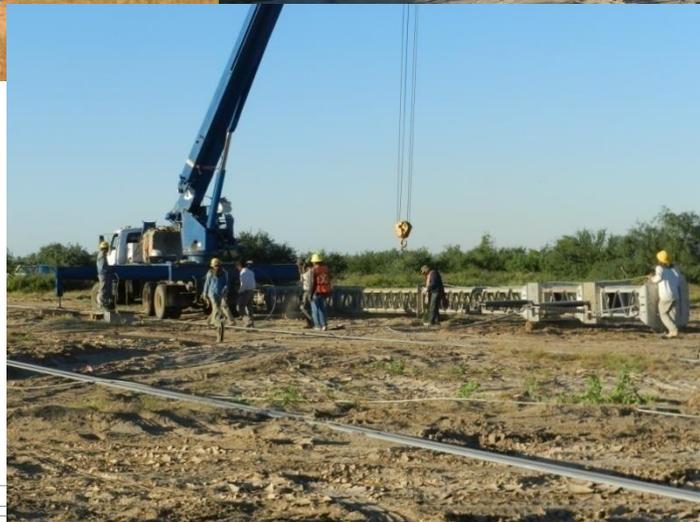
Removing provisional structures

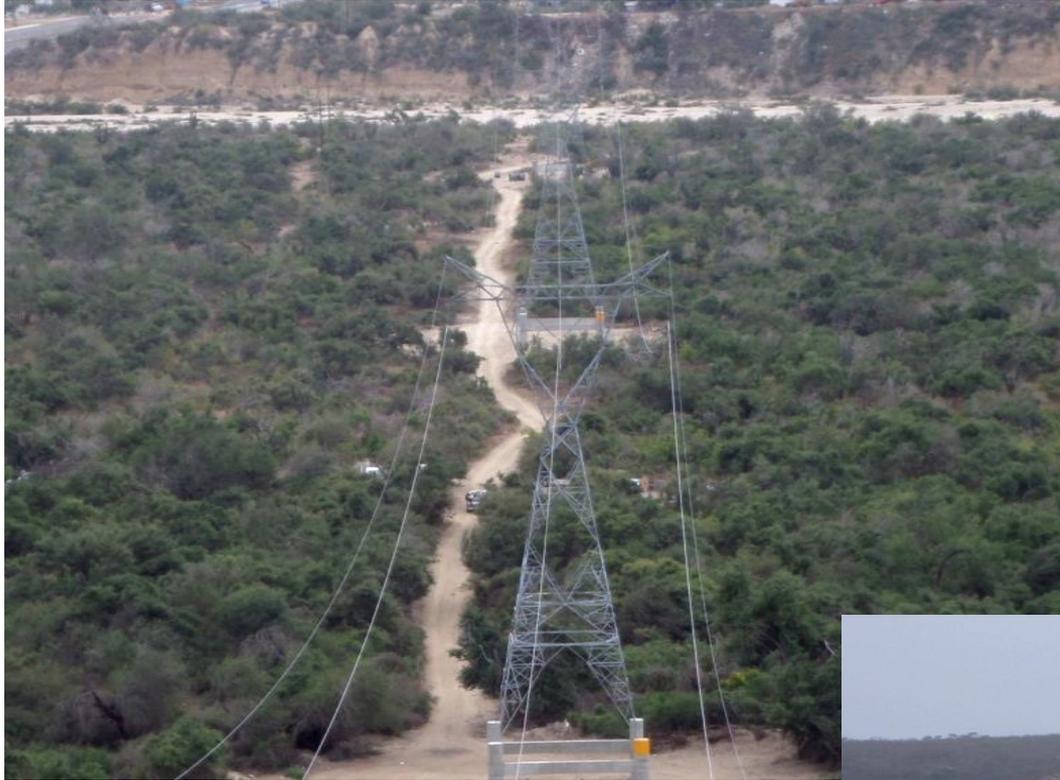
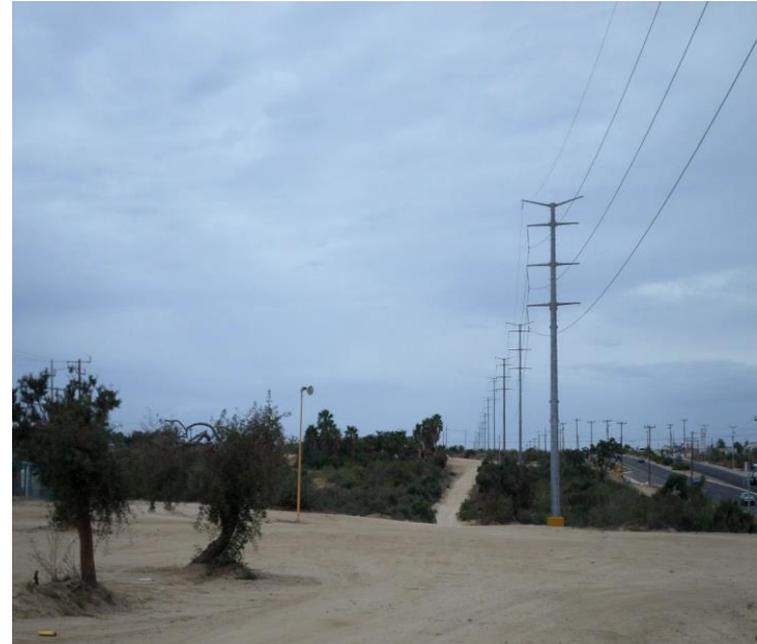
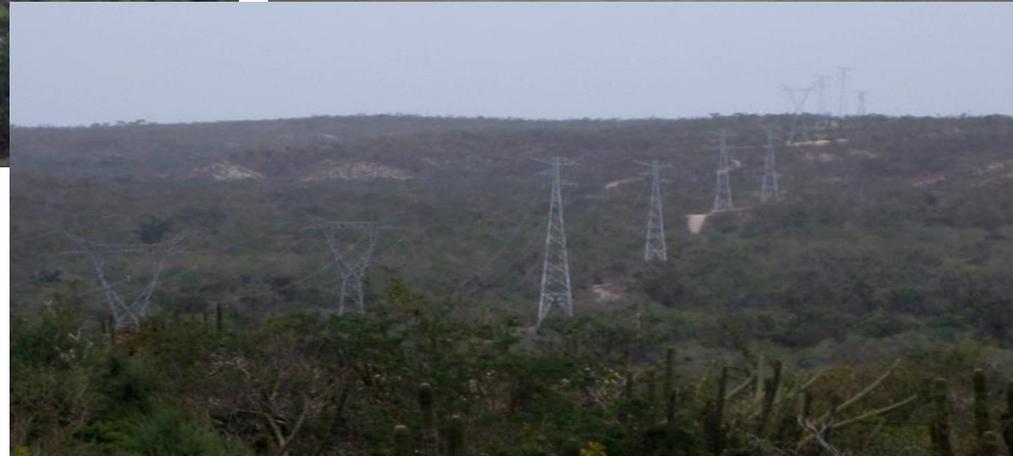
5.- Photographic Report Transmission Line rebuilt
