COMISIÓN FEDERAL
DE ELECTRICIDAD

Hurricane Odile

La Paz - Los Cabos, BCS

2015 PLS-CADD Advanced Training
and user group meeting

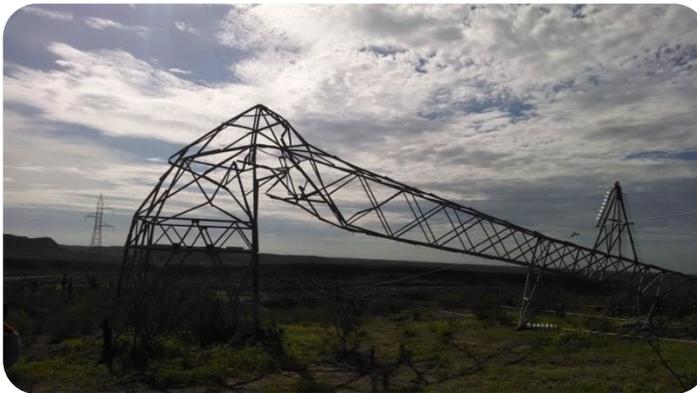
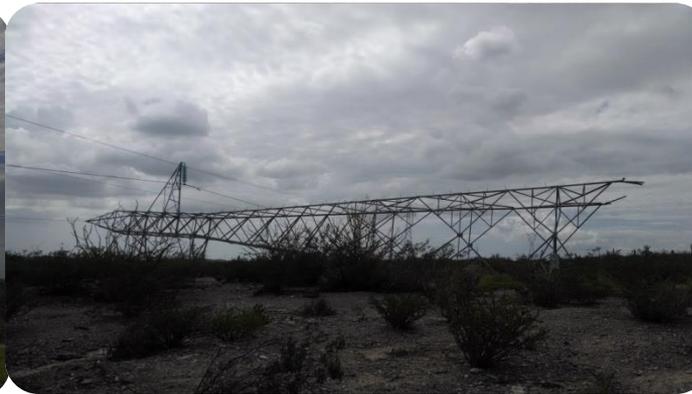
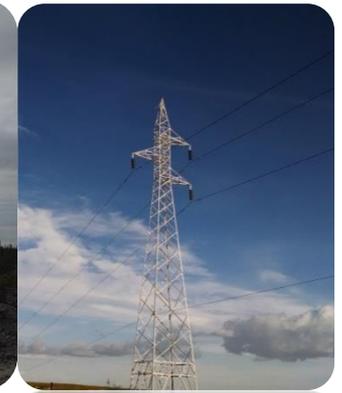
2.- Structures Location

The amount of damaged structures from steel towers, poles and structures formed by pole woods, amounted to **534** of which **481** suffered total damage and 53 other structures were possible to repair. With this stay the entire grid of power transmission at high voltage (115 kV circuits 27 and two 230 kV circuits) out of service from the Las Pilas switching substation, located approximately 120 km north of the city La Paz to the substation Los Cabos near Cabo San Lucas, knocking out the power supply to the municipalities of La Paz and Los Cabos.
